Architectural Conservation Proposal of Kashinath Bhaban: A Vivid Example of Colonial Architecture in Bengal

Shirajom Monira Khondker* and Nuzaba Binte Kabir

Assistant Professor, Ahsanullah University of Science and Technology (AUST), Dhaka-1208, Bangladesh

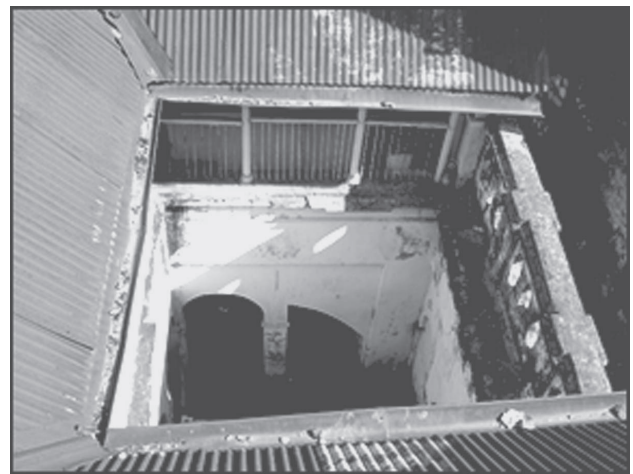
Figure 3: The courtyard of Kashinath Bhaban. (Source: Khondker, S.M., July 2013).

This is a courtyard type building; where on end of the court is lined with the boundary wall (Fig. 3). The concept of this type building is derived from centering on a courtyard. Actually the building activities and layout are organized around the courtyard. The courtyard (Fig. 3) of this building is confined, paved and exposed to sky. Here the courtyard is bounded by verandah on three sides with arched openings. The surrounding verandah acts as corridor and gives access to individual rooms. With arched openings and pilasters, the enclosing walls of the courtyard are extensively outlined.

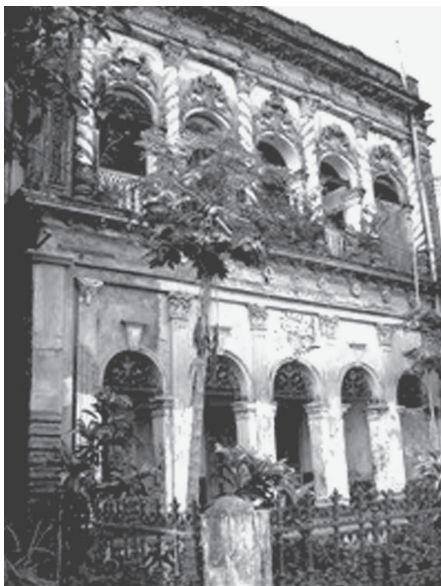
Figure 4: The front facade or street side view of Kashinath Bhaban showing flanking five openings at each level. (Source: Khondker, S.M., July 2013).

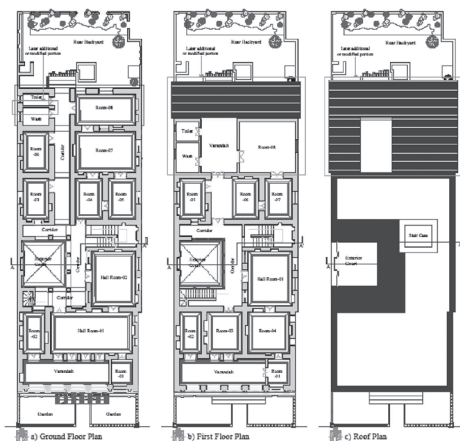
Figure 5: a) Ground floor plan, b) First floor plan, c) Roof plan of Kashinath Bhaban expressed building layout with building structural details. (Source: Khondker, S.M., July 2013 & prepared by the authors).

greater than frontage in this house. The width and length of the building facade is approximately 10.7m and 37m respectively (Fig. 5. a,b,c). Facades of this building are axially balanced with flanking five openings at each level (Fig. 4). With projected cornice, here the floor levels are articulated on the outside (Fig. 6). Parapets of this building followed a uniform design and heights with vertical slit openings, curved at the top and bottom (Fig. 7). A transitional space between the inner house and the street is created by the raised plinth and verandah which makes the entry of the building (Fig. 8).

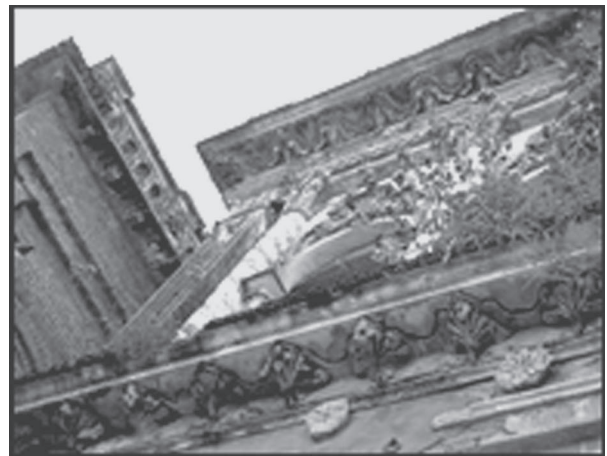
Figure 6: Projected cornice expressed floor levels. (Source: Khondker, S.M., July 2013).

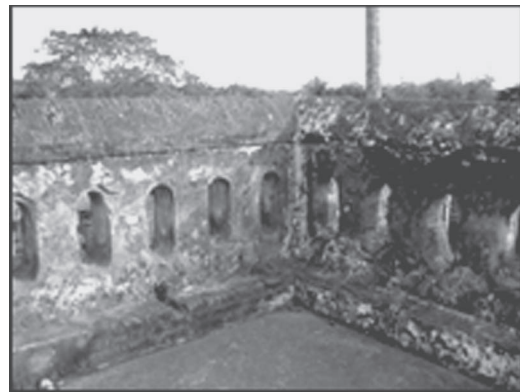
Figure 7: Parapet detailing in the roof. (Source: Khondker, S.M., July 2013).

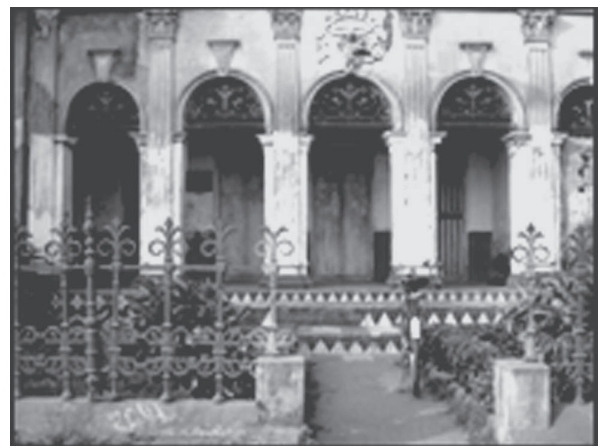
Figure 8: Raised plinth and verandah expressed entry. (Source: Khondker, S.M., July 2013).

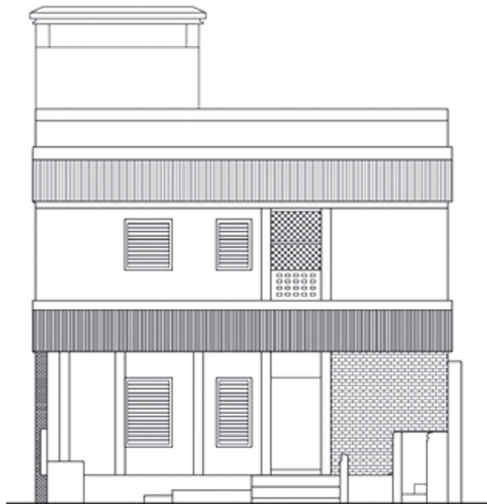
Figure 10: Back (North) side elevation showing later addition & modification of Kashinath Bhaban. (Source: Khondker, S.M., July 2013).

elevations of the Kashinath Bhaban (according to field study) are given below in fig. 9, 10, 11 & 12.

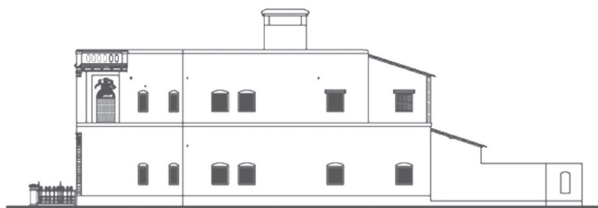
Figure 11: East side elevation of Kashinath Bhaban. (Source: Khondker, S.M., July 2013).

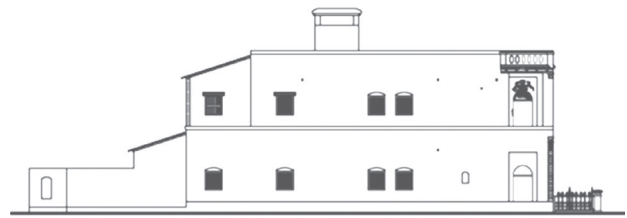
Figure 12: West side elevation of Kashinath Bhaban. (Source: Khondker, S.M., July 2013).

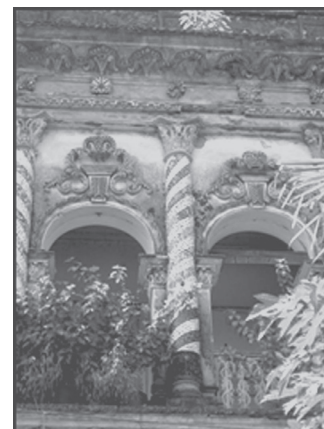
Figure 13: Plaster decoration and chinitikri work of the front facade. (Source: Khondker, S.M., July 2013).

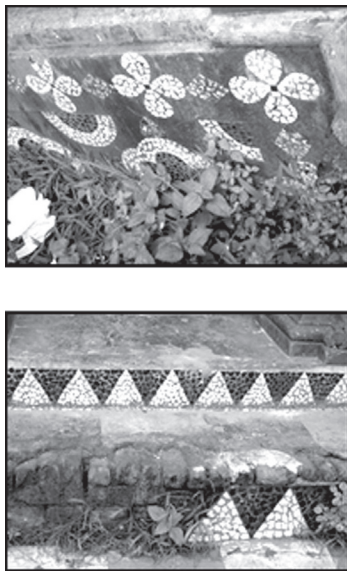
Figure 14: Use of decorative colored broken tiles on the step riser. (Source: Khondker, S.M., July 2013).

ornamentations of this building are expressed accurately. The plinth of this building is fairly raised from the Panam Street which has neat cement finish (Fig. 14). Decorative colored broken tiles were used on the step riser in front of the entrance verandah or raised plinth (Fig. 14).

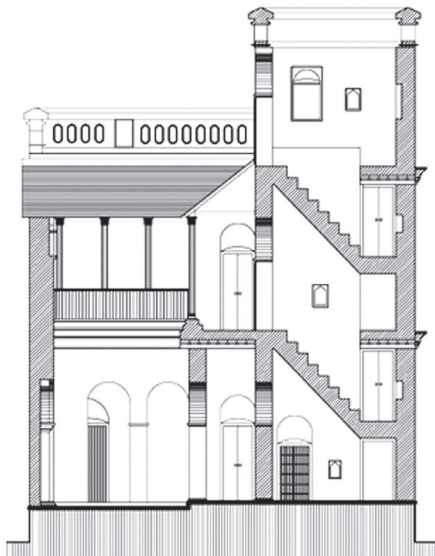
Figure 15: Section – AA' through the inner courtyard and stair case. (Source: Khondker, S.M., July 2013).

According to the necessity of surface articulation, the primary construction material was brick which have been modeled in precise form. For facade delimitation bricks are plastered here. The thickness of brick work in walls vary between 50 to 70 cm (Fig. 5. a,b,c) & (Fig. 15). Lime mortar has been used primarily for bonding. On the top of upper level verandah, corrugated sheets were placed sloping down towards the courtyard (Fig. 3) & (Fig. 15). In facade design and interior ornamentation plaster decoration have been extensively applied (Fig. 13). Here as a common decorative element, fabricated wooden doors and windows molded with plaster were also applied. Cast iron brackets, ventilators, window grills, railings, balusters had been extensively used. Ornamentation was made by lime *surki* and plaster (Fig. 13). In the columns of the front facade for decoration with broken china locally known as *chinitikri* work has been done (Fig. 13). Decorative colored broken tiles were used on the step riser in front of the entrance verandah (Fig. 14). Structural details will be clear by a section through inner courtyard and stair case (Fig. 15).

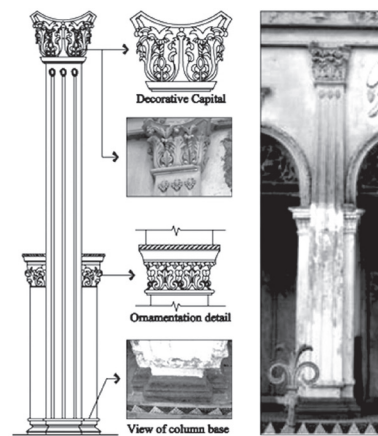
Figure 16: Corinthian pilaster (ground floor) with decorative capital, shaft & base. (Source: Khondker, S.M., July 2013 & prepared by the authors).

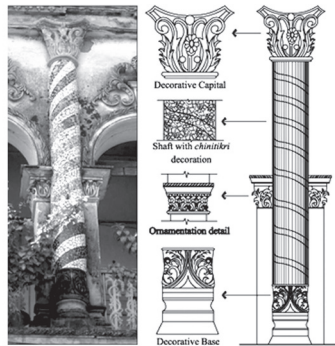
Figure 17: Round columns with Corinthian capital (upper floor) with decorative capital, shaft & base. (Source: Khondker, S.M., July 2013 & prepared by the authors).

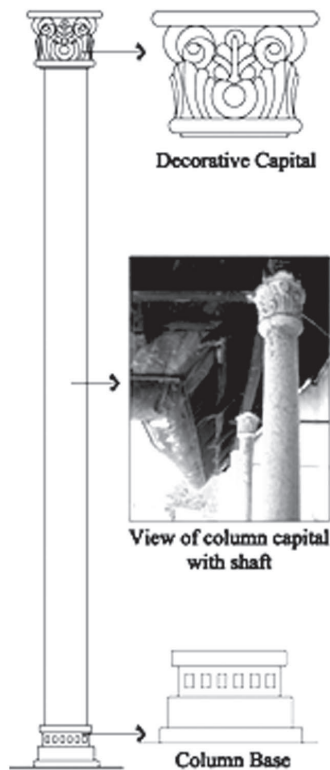
Figure 18: Use of painted cast iron column in the upper floor verandah with decorative capital, simple shaft and base. (Source: Khondker, S.M., July 2013 & prepared by the authors).

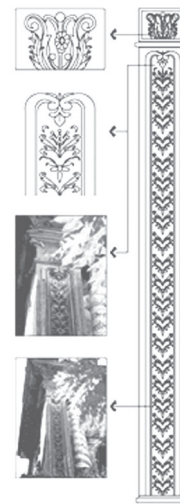
Figure 19: Corner of the building with floral decoration. (Source: Khondker, S.M., July 2013 & prepared by the authors).

The emphasis of the facade configuration is formed by the design of the entrance of this building. The front facade of this building was articulated by round columns with Corinthian capital in the upper floor (Fig. 17) and Corinthian pilaster in the ground floor (Fig. 16), semi-circular arches with pediments and various other decorative elements. The upper floor columns in the exterior facade have *chinitikri* decoration consisting of dark color spiral band in a distinct pattern (Fig. 17). For the support of the upper floor verandah roof structure, where corrugated sheets were placed sloping down towards the courtyard, the painted cast iron columns are used (Fig. 18). The pillars, columns and pilasters are all designed with well-defined base, shaft and capital with tremendous decorative elements (Fig. 16, 17 & 18). Corner of the building is emphasized with decorative floral treatment (Fig. 19 & 20).

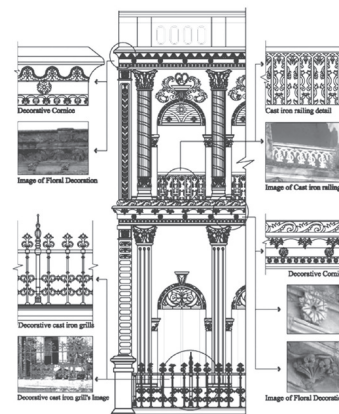
Figure 21: Architectural decoration & ornamentation details of Kashinath Bhaban. (Source: Khondker, S.M., July 2013).

Regular and simple doorways are noticed here and windows are considered with semi-circular arches bounded in a rectangular or square frame. Closed window, blind arches and shuttered doors create a noticeable tendency to illusionist representations. To express a local identity, indigenous floral pattern are used entirely at the apex of the semi-circular arches (Fig. 21, 22 & 23).

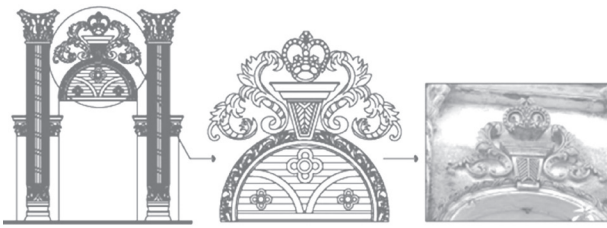
Figure 22: Decorative arch with lime surki & plaster. (Source: Khondker, S.M., July 2013).

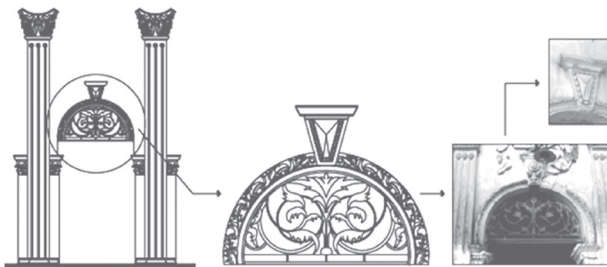
Figure 23: Cast iron decorative arch in doorway. (Source: Khondker, S.M., July 2013).

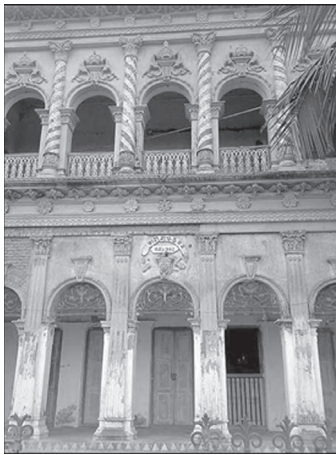
Figure 24: Parapet details with vertical slit openings, curved at the top and bottom. (Source: Khondker, S.M., July 2013).

classical buildings. In this building cast iron brackets, ventilators, window grills, railings, balusters had been widely used with outstanding floral ornamentation (Fig. 21, 22 & 23). Parapets followed a uniform design and heights with vertical slit openings, curved at the top and bottom (Fig. 24). True to the style, railings, key-stones, column capital, base etc. have been thoroughly decorated.

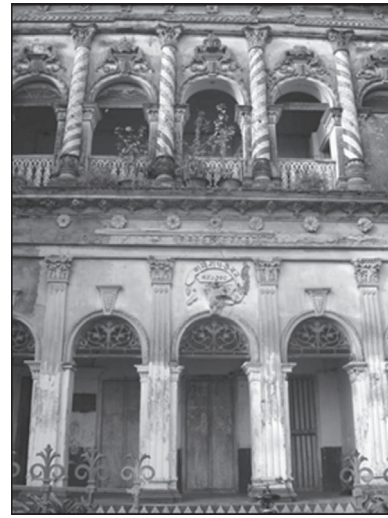
Figure 26: Previous front view of Kashinath Bhaban. (Source: Photograph of 2006 by authors).

of exterior facades is gradually destroyed for lack of preservation (Fig. 26). Recently the archeology department of government of Bangladesh, as a part of taking an action in preservation process, colored this historical building “Kashinath Bhaban” into Pink color (Fig. 25). This has an impact in destroying the originality of the structural, materials, and architectural ornamentation details gradually, which were the historical and socio-cultural evidence of our past.

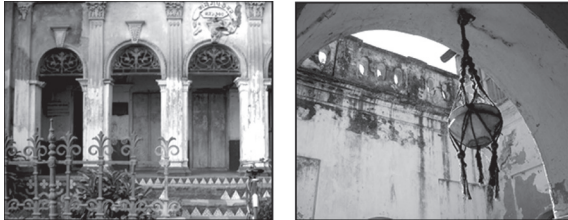
Figure 27: Exterior and interior walls of Kashinath Bhaban that is plastered with cement mortars is need to de-plaster. (Source: Photographs taken by the authors).

- 3) The next step that will be taken in this restoration proposal is de-plastering of all interior and exterior walls that were plastered with cement mortar to expose the original masonry wall plastered with lime mortar (Fig. 27). De-plastering will be done primarily to ensure the structural stability of all masonry wall which will help us to prepare an authentic intervention plan.

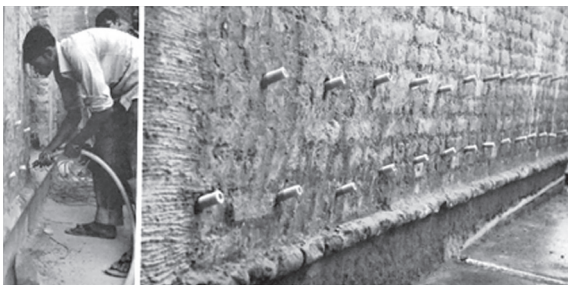
Figure 28: An example of insertion of damp proof course (DPC) into the existing wall. (Source: Ahmed, 2015).

- 4) Wet wall or dampness is a common problem in old buildings. To prevent the rising damp in properties, it will be considered to insert a new physical membrane damp proof course (DPC) into the existing wall (Fig. 28).

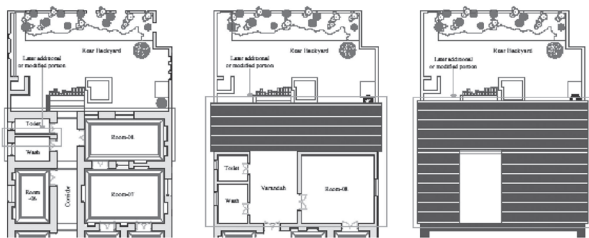
Figure 29: Partial plan with extention or modified portion of new construction. (Source: Field Survey & prepared by the authors).

- 5) To restore the original morphology of the building, it is necessary to remove of all the new developments including extension or modified portion of new construction (Fig. 29).

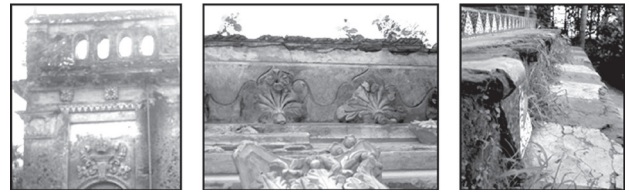
Figure 30: Growth of several strangler figs in the building. (Source: Photographs taken by the authors).

- 6) The growth of several strangler figs in the exterior and interior masonry walls or other parts of the building (Fig. 30) should be removed properly.

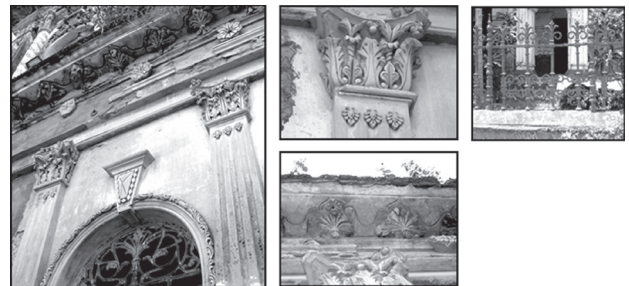
Figure 31: Some missing attributes, such as floral ornamentation, cast iron railing etc. (Source: Photographs taken by the authors).

- 7) Repairing of cracks should be done in proper way which are found in the Kashinath Bhaban building.
- 8) An authentic intervention proposal measured and photographic documentation for the reconstruction of few missing attributes (Fig. 31, 32, 33, 34, 35, 36 & 37), such as cast iron railing, door and window panel, steps, floor pattern, chinitikri and floral ornamental details should be done accurately.

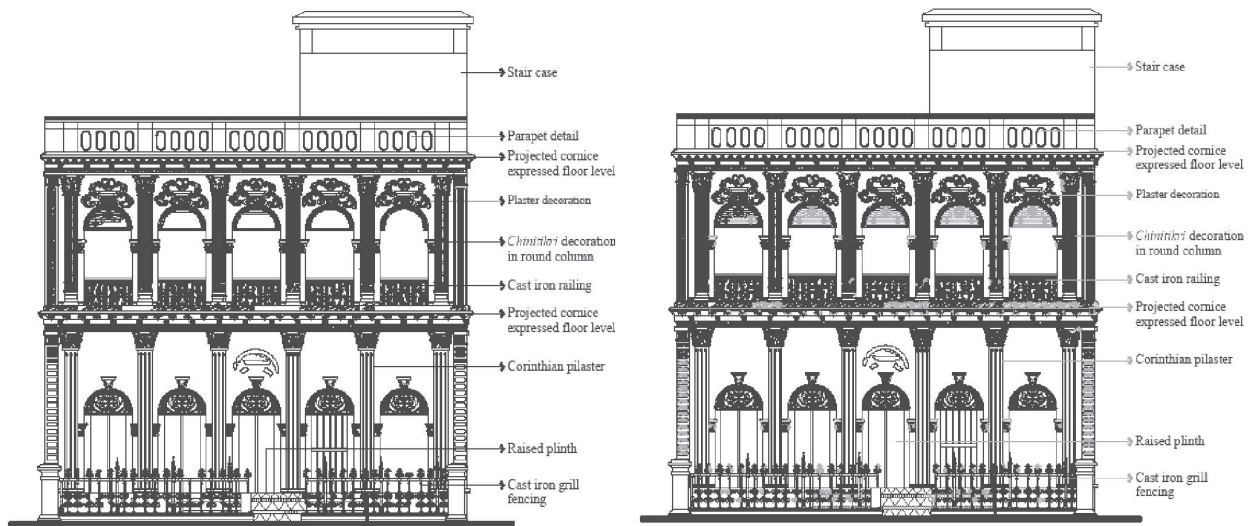
Figure 33: Comparison images of the front elevation of Kashinath Bhaban between existing and through restoration proposal. (Source: Field Survey & prepared by the authors).

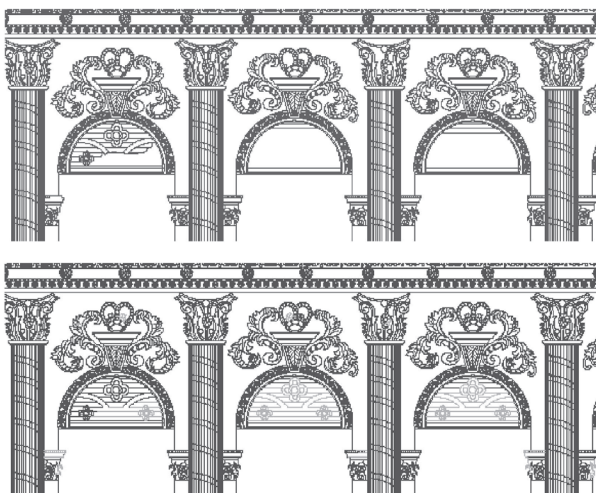
Figure 34: Comparison images of the Partial elevation with some missing floral ornamentations & decorations between existing and through restoration proposal. (Source: Field Survey & prepared by the authors).

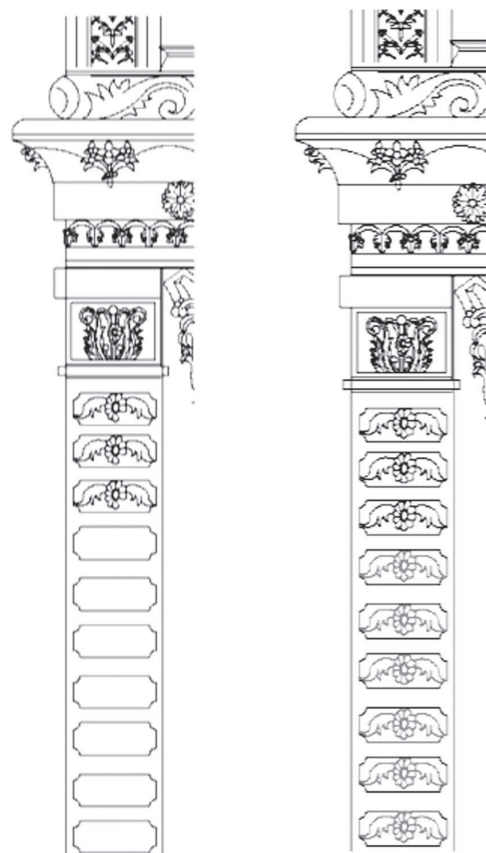
Figure 36: Comparison images of the Partial elevation with some missing plaster decorations of the edge column between existing and through restoration proposal. (Source: Field Survey & prepared by the authors).

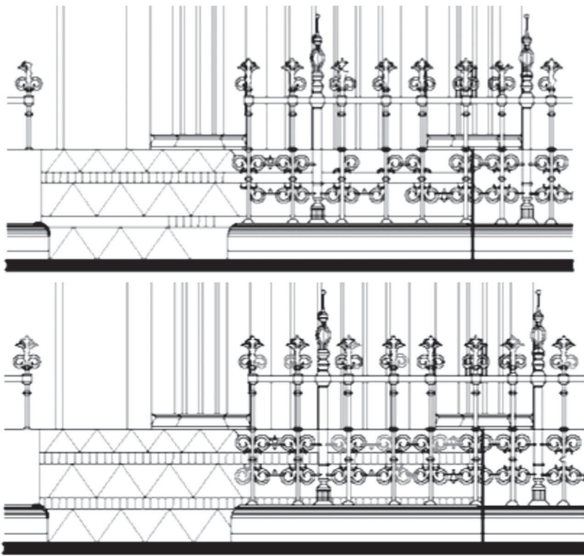
Figure 37: Comparison images of the Partial elevation with some missing floral ornamentations & decorations of the cast iron between existing and through restoration proposal. (Source: Field Survey & prepared by the authors).

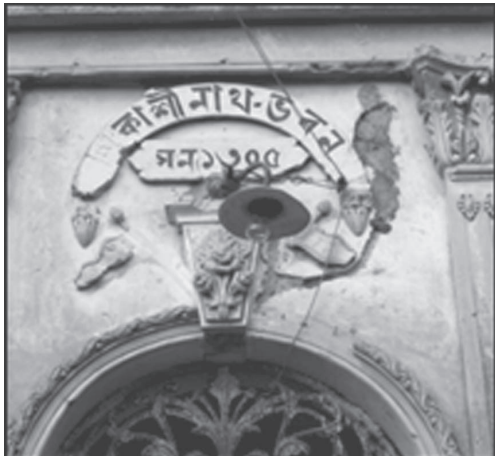
Figure 38: Some missing attributes could not recognized. (Source: Photograph taken by the authors).

- 9) Through the authentic intervention proposal for the restoration work as conservation technique, the missing detailing of the entry facade above the arch could not recognized or documented properly by the authors (Fig. 38). Therefore, it should be restored by the proper investigation from the historical past.
