A Study of Conservation Interventions at Ram Bagh, the Summer Retreat of Maharaja Ranjit Singh at Amritsar

Mona Malhotra

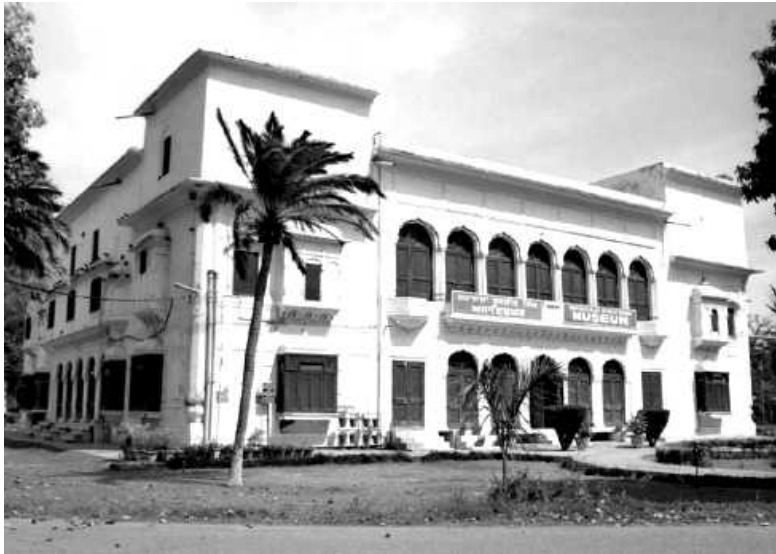
Figure 4: The Summer Palace before restoration (Source: ASI)

Transformations over Time & Current Condition – The building underwent several changes when converted as the office of the British Raj Deputy Commissioner. Additional rooms were created by closing open arcades of the Durbar Hall, and projected balconies were covered with wooden doors. New windows and fire places introduced. At places the original marble flooring was replaced by cement tiles. During the Second World War the Palace was occupied by the Civil Defense Organization. In the 1970s it was used by the local Municipal Corporation, and then converted into a museum in November 1977. While no preventive maintenance was undertaken during this entire period, several incongruous additions were made, interior walls were white washed obscuring original artwork. Many of the original timber roofs had deteriorated due to seepage and termites in the absence of proper maintenance. Almost all of these were inadvisably replaced with RCC construction, just as of cement-based plaster and mortar was used for repairing masonry.

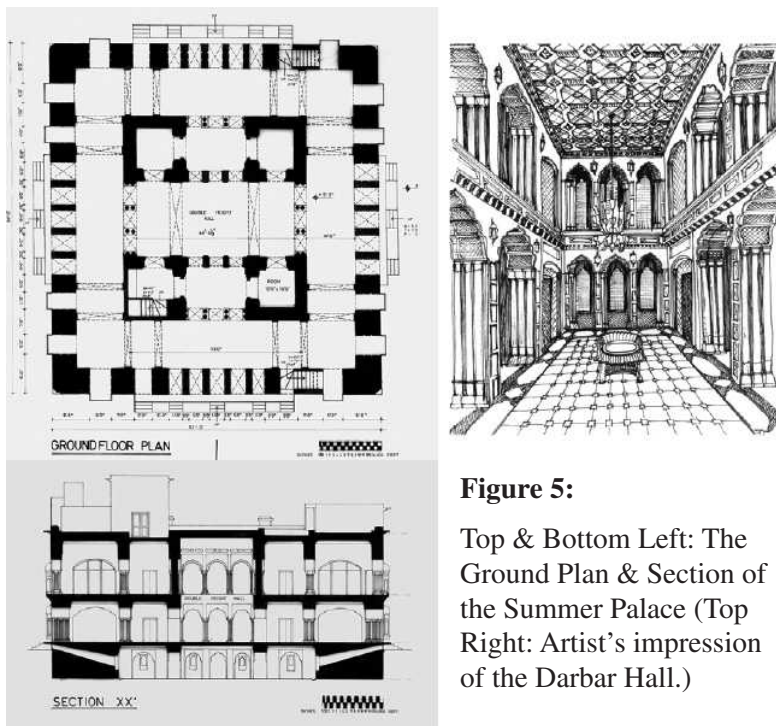
Figure 5:

Top & Bottom Left: The
Ground Plan & Section of
the Summer Palace (Top
Right: Artist's impression
of the Darbar Hall.)

of 678.18 kanals⁵, it is a large double-storied structure, square in plan with rooms and passages arranged symmetrically around a central, double-height Durbar Hall. The 21 feet thick walls of the basement were punctured with funnel-like windows to channelize air movement and allow diffused light inside to create cool comfort conditions (Figures 4 & 5). The palace was built with Nanakshahi bricks set in lime mortar,⁶ with roofs of timber joists and rafters, and was richly ornamented, both inside as well as outside.

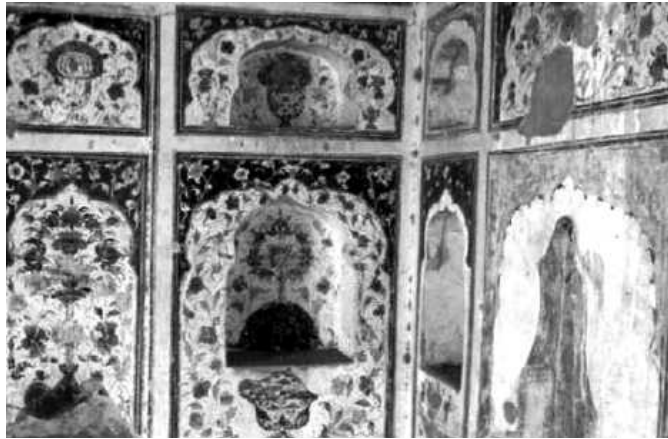
Figure 6:
Extant Wall
Frescoes in the
Summer Palace

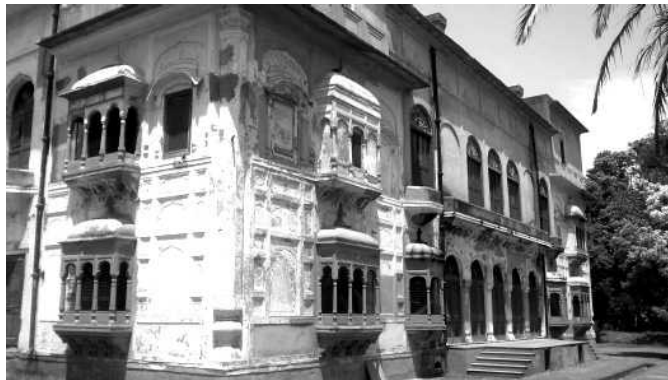
Figure 8:
The Summer
Palace during
restoration, layers
of plaster were
peeled off to
reveal original
details.

materials are being recovered. Multiple layers of cement plaster and paint were removed to access original materials, features and details (Figure 8). The original flooring, wherever found, is being preserved and consolidated, with cracks being filled with lime concrete. Removal of the later cement-based flooring on the first floor has revealed the original *nankshahi* brick flooring. The RCC roof has been removed and a new ‘combination’ roof has been built of traditional wooden battens and steel joists. The second aspect of conservation concerns reconstruction and reproduction and of missing artwork and details. This entails removal of old decayed timber rafters and joists and reconstruction of traditional wooden roof as well as repairing and replacing the damaged *Khatamband* ceiling tiles (Figure 9).

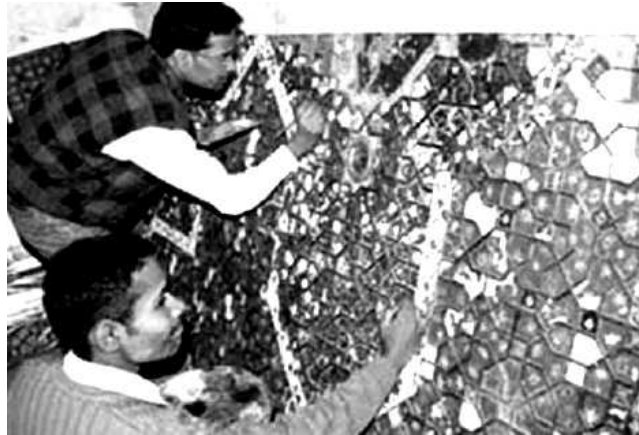
Figure 9:
Restoring the
Khatamband ceiling

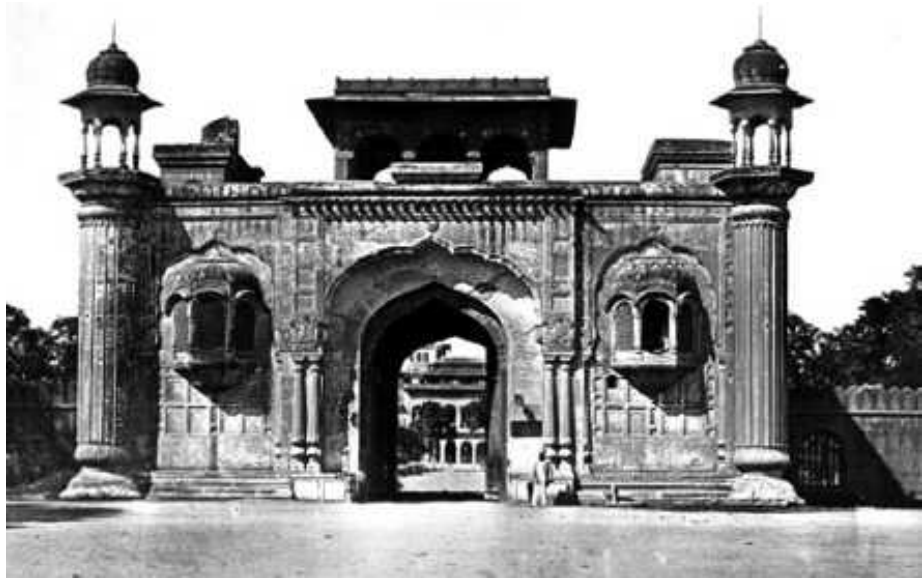
The Original Design – Situated in the southern wall of the garden, the *Deorhi* is the main entrance gateway to the Ram Bagh Complex, and the beginning of the ceremonial processional route of Maharaja Ranjit Singh from the Palace to the city. It is almost square in plan and consists of a central covered passage flanked symmetrically by two-storeyed wings with guard-rooms staircases on each side. Each room is a square-shaped with recessed niches in the middle of its side walls. The *Deorhi* is considered to be a blend of both Mughal and Rajput Architecture. The northern and southern façade have a huge central archway, flanked by a rectangular bay on each side containing an ornamental *jharokha*. The exterior as well as interior of the *Deorhi* is decorated with floral and geometrical designs (Figure 10). The roof terrace is animated with a centrally

Figure 10: An old photograph of the Deorhi. (Source: ASI)

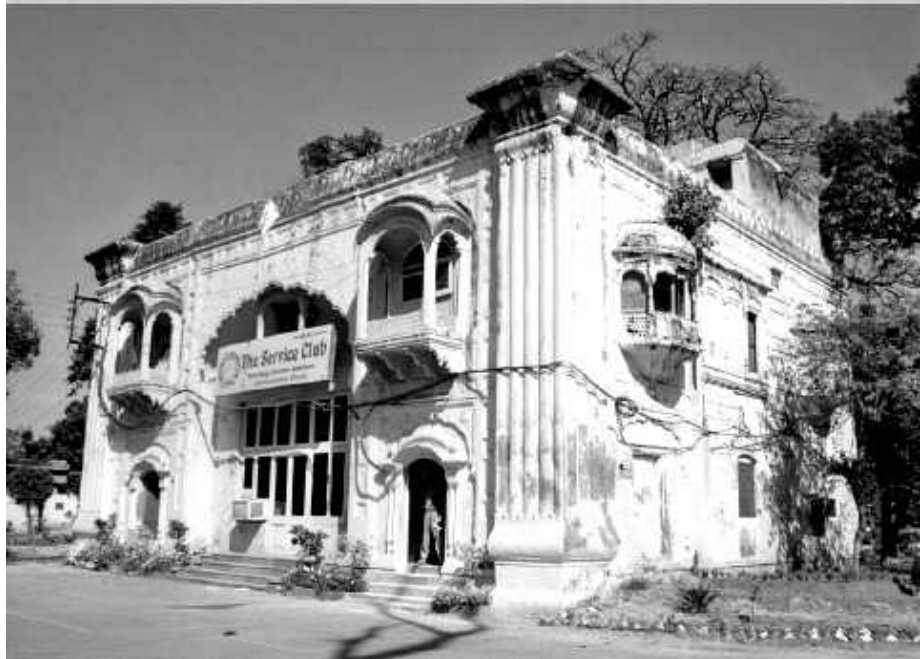
Figure 12: A recent picture of the Inner Gate or the ‘Service Club’

Transformations over Time & Current Condition – There is no evidence of British interventions. But, after independence, the structure was given for use as the ‘Service Club’. Today, the building is in a dilapidated condition due to lack of maintenance and incongruous additions, besides the deleterious impact of climatic factors. The interior has been changed totally and the traditional timber roof replaced by an RCC one. Damage due to dampness is apparent in most parts of the building. The façade too has blackened due to atmospheric pollution aggravated by vehicular movements (Figure 12).

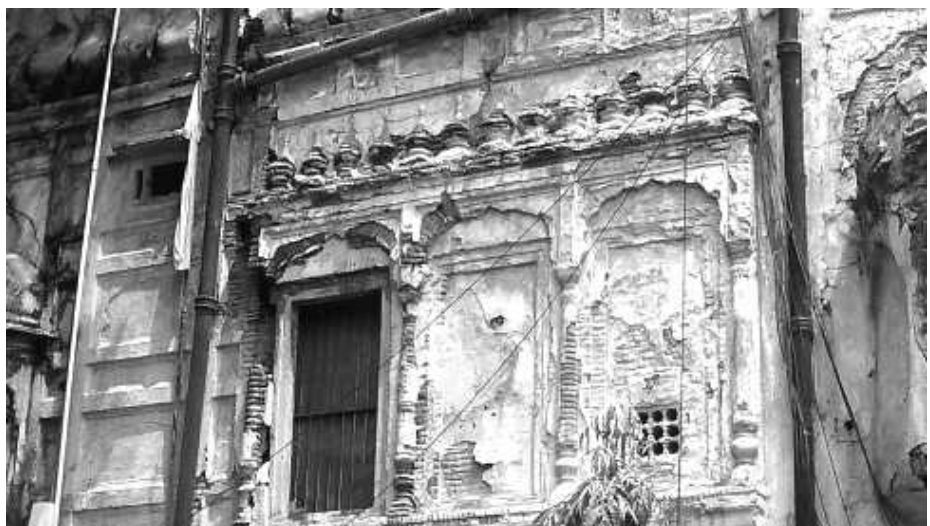
Figure 13: Damage to the ‘Service Club’ due to neglect, misuse and abuse.

Multiple layers of cement-based plaster and coats of paint have been used to ‘repair’ the building marring the original aesthetics. External sandstone features have been lost under multiple coats of limewash. Original balconies and openings have either been closed or doors/ windows have been added. Addition of toilets on the upper floor necessitated installation of sewerage pipes, which are the main cause of seepage and dampness, resulting in plaster deterioration, vegetal growth, damage to masonry and development of cracks. The new plumbing and rain water pipes, the overhead cables for electrical supply and air conditioning units affixed to exterior walls are insensitive interventions that create visual clutter and ravage the authenticity of the historic structure. No conservation action has yet been started (Figure 13).

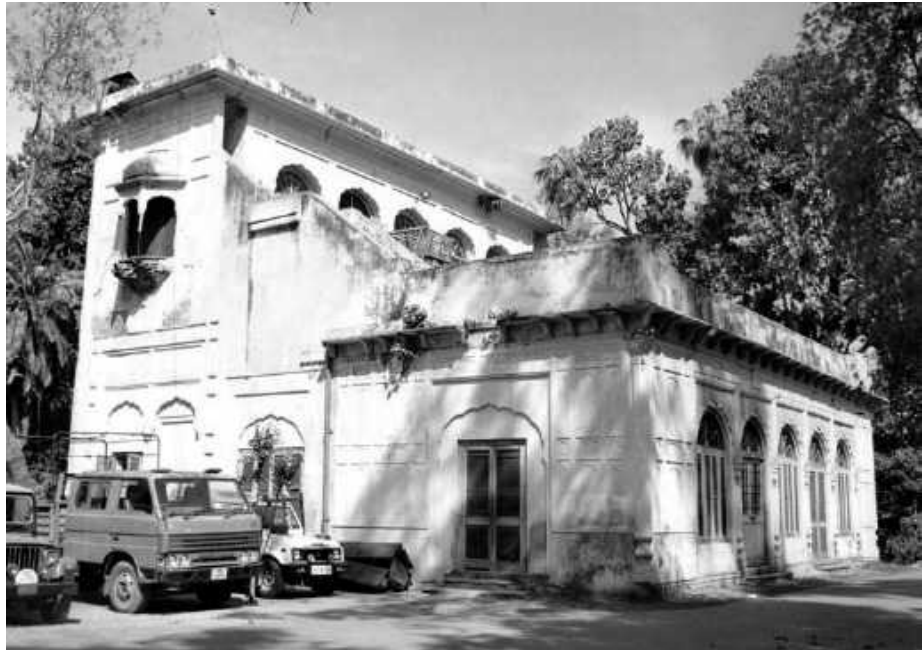
The Original Design – This *Munshikhana* lies on the western end of the E-W axis and was originally used as an office by Maharaja Ranjit Singh’s courtiers. Square in plan and built on a low plinth, this structure has a flat roof and an open rectangular pavilion at the front. The front elevation of the building is a symmetrical composition of five arched openings framed by sleek and slender columns. The end bays of the lower story are treated with a composition of rectangular panels. The rear, western wall is pierced by a gateway. The side elevation, with projected balconies and cusped arches within rectangular frames, is a fine example of an asymmetric composition of a variety of elements brought together. Walls throughout the building are decorated with vertical and horizontal stripes in low relief and flanked on their extreme ends by fluted plasters, with decorative *ghata* shaped bases. *Nanakshahi* bricks have been used for the masonry whereas the pavilion arches, eaves and brackets are in red sandstone. (Figure 14)

Figure 14: The western Munshikhana used for 'Civil Defence'.

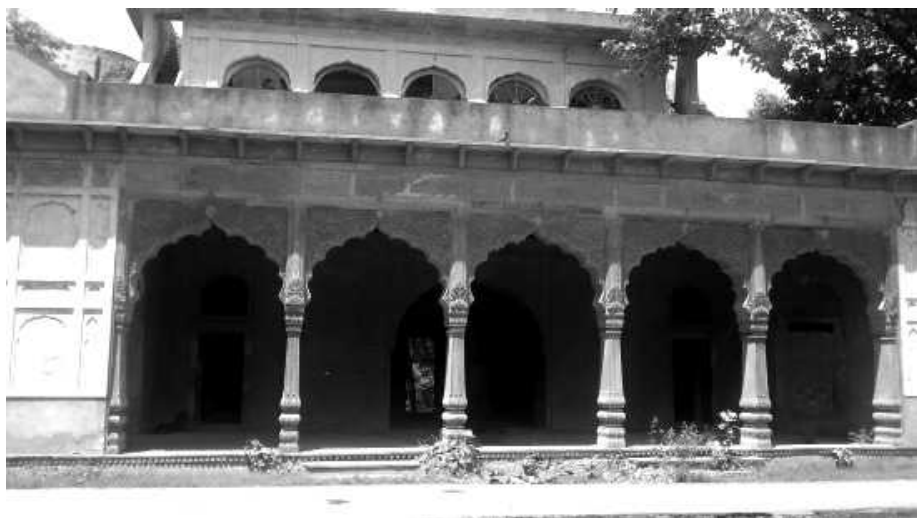
Figure 15: Front pavilion of the western Munshikhana after restoration

Transformations over Time & Current Condition – During the British period, the building was used as an office, and doors, windows and partitions were added to the original structure. The flooring was completely changed from a traditional brick floor to cement concrete tiles. After independence, the building was handed over to Civil Defence authorities, and lime-washed repeatedly. Cracks developed in the arches due to ground subsidence, while vegetation growth and leakage from the roof terrace caused multiple problems.

Conservation Action – Doors, windows, coats of paint and plaster added later have been removed to reveal the original features and materials. Brick masonry has been consolidated by pointing, edging, stitching and filling gaps. Timber joists have been replaced with steel girders (Figure 15).

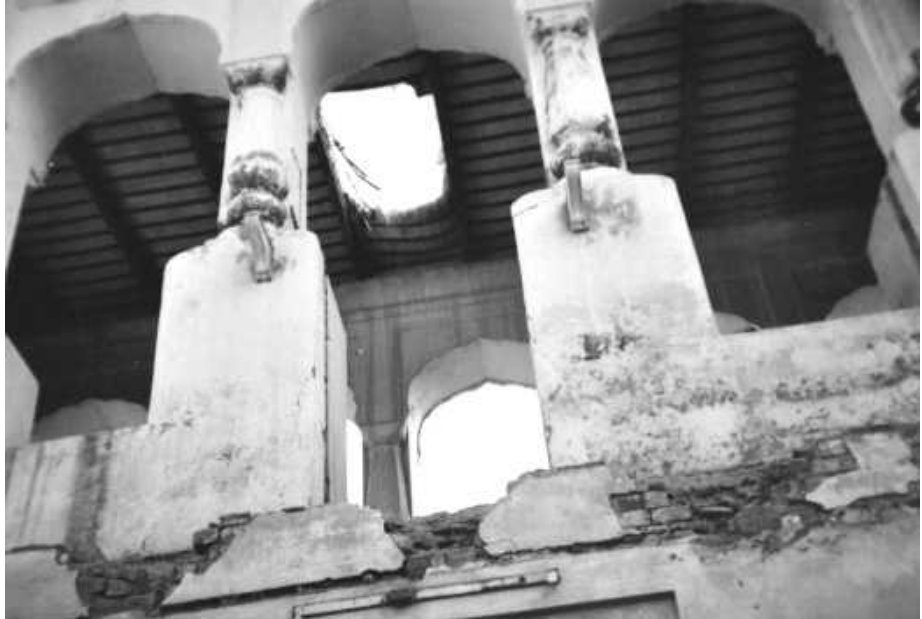
Transformations over Time & Current Condition – The building was used as a library during the British era. Alterations include layer of cement tiles on floors, closing openings and adding partitions. In 1977, the building was converted to an aquarium and has since then retained the name of “Machhi Ghar”. When the officials of ASI inspected the building in 2008, the walls were severely damaged due to seepage and inappropriate repairs. The masonry had deteriorated in the absence of regular maintenance. Negligence had caused extensive vegetation growth over the roofs. The wooden doors and windows were badly decayed (Figure 16).

Figure 16: Damaged interiors of the Eastern Munshikhana

Conservation Action – The building is under restoration. Growth of vegetation on the roof has been removed, the decayed roof has been reconstructed as per the original details and internal walls have been treated with lime plaster

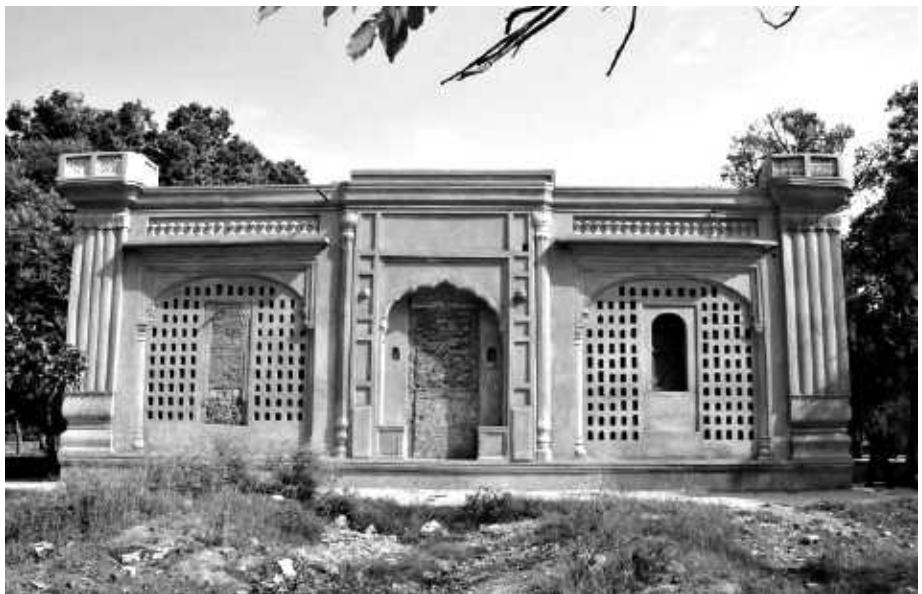
Figure 17: The Hamman

The Original Design – The *Hammam* lies towards the north-west of the Summer Palace, located on a diagonal axes. It is a square-shaped, single-storeyed building, within which is an 8’-6” deep L-shaped tank, and a square room. The southern front wall of the building is divided into three recesses, the central one being its main entrance. Side recesses are decorated with numerous rows of small niches used for placing lighted lamps. There are round pilasters at the four angles of the exterior wall, surmounted by square parapets of *jaalis*. Walls terminate into projected eaves with a *guldasta* above (Figure 17).

Transformations over Time & Current Condition – The historic structure was badly damaged when it was converted into a modern swimming pool by the Municipal Committee in the mid 20th century.

Conservation Action – Wall cracks were repaired by stitching and filling up gaps. Broken eaves and parapets were repaired and the enormous growth of vegetation on the roofs was removed. Seepage of water from roof top was arrested by filling the gaps and joints of the stone. Peeled plaster was raked out and re-applied. The original decorations were restored.

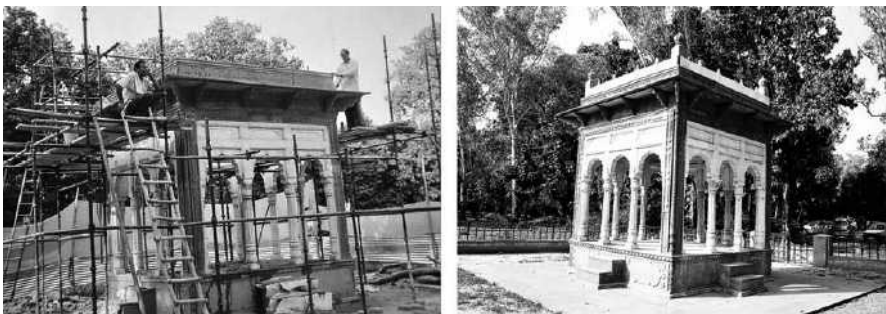
Figure 18: Chhoti Baradari, during and after reconstruction

The Current Condition – The roof and parapet of the *Baradari* collapsed due to seepage, vegetal growth and termite attack. Moreover the roots of a tree in close proximity had posed a great threat to its foundations. With the passage of time and due to negligence, the original flooring – laid in a specific pattern with black and white marble – was completely damaged.

Conservation Action – This *Baradari* too had to be completely dismantled and reconstructed. It was brought down piece by piece, with all the members being carefully numbered. Then these members were placed back to their original position. The roof has been restored using the original construction technique, i.e., timber joists and rafters. Flooring has been laid in white marble tiles, though in a simple pattern, and not as per the original one. Later on, after the *Baradari* had been restored, an apron almost 2.0 m wide was provided and enclosed by a railing to protect it from further damage (Figure 18).

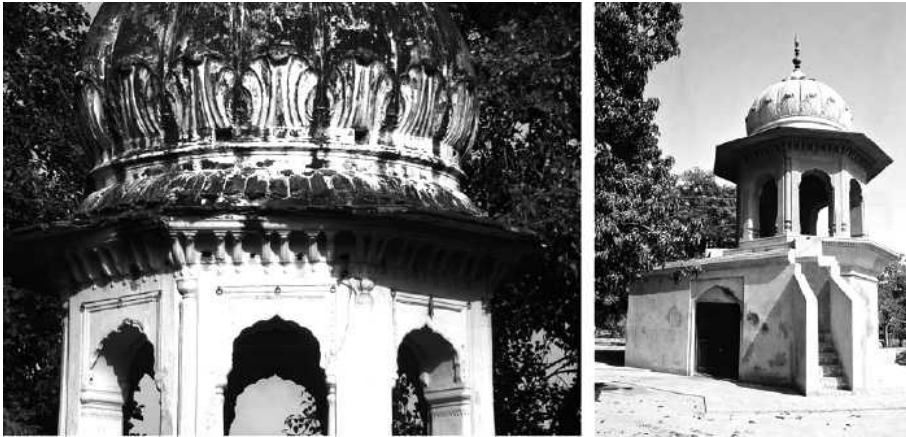
Transformations over Time & Current Condition – Just as all other buildings, the *Burjis* were also in a dilapidated condition due to negligence, lack of maintenance, dampness and inappropriate repair works. The original *Nanakshahi* brick masonry had decayed due to dampness and absence of regular preventive repair, and had been replaced by modern bricks laid in mud mortar. The octagonal stone eaves had also deteriorated due to rain while roots of nearby trees posed further threat.

Figure 19: One of the *Burjis* – before and after conservation

Conservation Action – The modern bricks used in the lower masonry were removed and the structure reconstructed with original bricks laid in lime mortar. For further consolidation, underpinning of the foundation walls was done to prevent seepage into the structure. Cement plaster was replaced by lime plaster and the rotten door of the guard room was replaced with new door constructed as per the original material. Brick tile flooring of the watch towers was preserved in its original condition. The tree that posed a threat for the structure was removed (Figure 19).
