# **Using Traditional Knowledge Systems for Post-disaster Reconstruction – Issues and Challenges following Gujarat and Kashmir Earthquakes**

**Rohit Jigyasu**

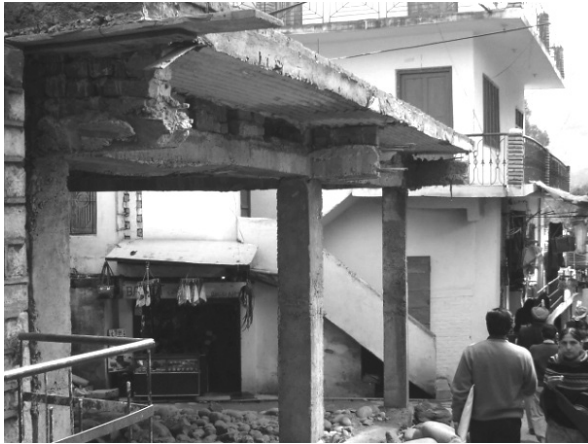
**Figure 1:**

Poor contemporary construction in Indian-administered Kashmir with an RCC slab cast on two or three courses of brick placed over beams, which are not even at the same level.

In both the cases, most structures whether 'modern' or 'traditional', suffered enormous damage causing a massive loss of life and property. Many 'modern' reinforced cement concrete (RCC) constructions, which were largely perceived to be stronger in comparison to traditional structures, were of extremely poor quality. In Kashmir, it was found that many of these buildings did not even follow the basic structural principles of construction in RCC. In many cases, the roof slab was not even resting on the beams. Rather it was cast on two or three courses of brick placed over the beams and, in some constructions, these beams were not even at the same level (Figure 1).

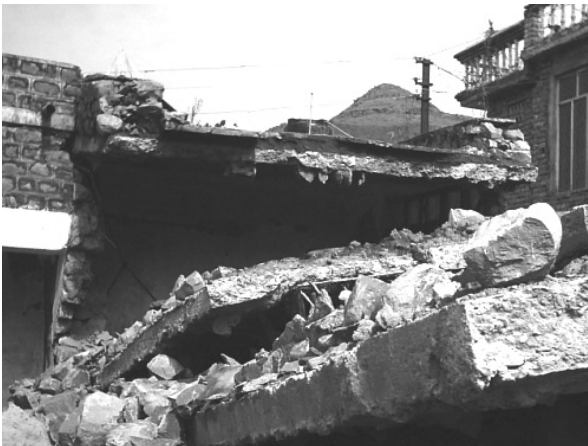
**Figure 2:**

The roof slab had virtually no reinforcement bars and, the layers of mud that had accumulated on top increased the dead load. As a result, the structure cracked and collapsed like a pack of cards due to the impact of the earthquake.

In other cases, the roof slab had been cast virtually without reinforcement bars, while layers of mud for terracing on its top had further increased the dead load. As a result, the roofs simply cracked and collapsed like a pack of cards due to the impact of earthquake (Figure 2). In many structures, even the columns had inadequate reinforcement. There were also instances where structures, with RCC beams resting on slender brick piers, simply gave way due to lateral impact of earthquake.

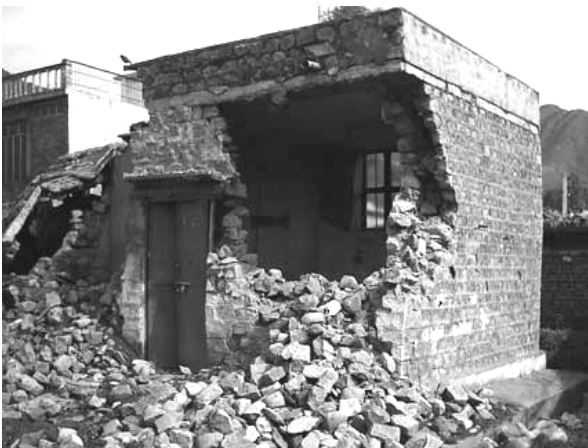
**Figure 3:**

These random rubble masonry walls collapsed during the earthquake due to improper bonding and the absence of through stones.

Most of the traditional structures built with poor quality stone masonry also did not perform well. Although many stone walls were clad with well laid out stone courses, their inner core was built of weak random rubble masonry laid in poor mud mortar. Due to improper bonding and absence of through stones, these walls simply collapsed due to earthquake. (Figure 3) Inadequate corner joints between the perpendicular walls were also one of the reasons for poor behavior of these buildings. In the case of historic structures with sloping roofs, sometimes the free-standing gable walls could not withstand lateral forces of earthquake and simply collapsed.

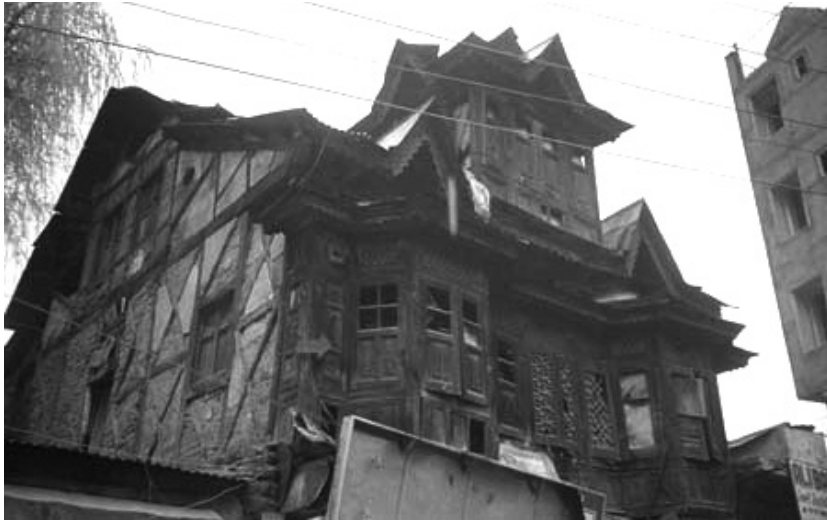
**Figure 4:** Vernacular houses in Poonch using Kashmiri techniques of Dhajji Dewari (timber frame with masonry infill) performed much better during the earthquake than many of the poorly built ‘modern’ structures.

The vernacular structures built using local Kashmiri building techniques of Taq (timber laced masonry bearing wall) and Dhajji Dewari (Timber Frame with Masonry Infill) performed much better than many poorly built ‘modern’ structures. Although there were cracks in the masonry infill, in most cases these structures did not collapse, thereby preventing loss of life (Figure 4).

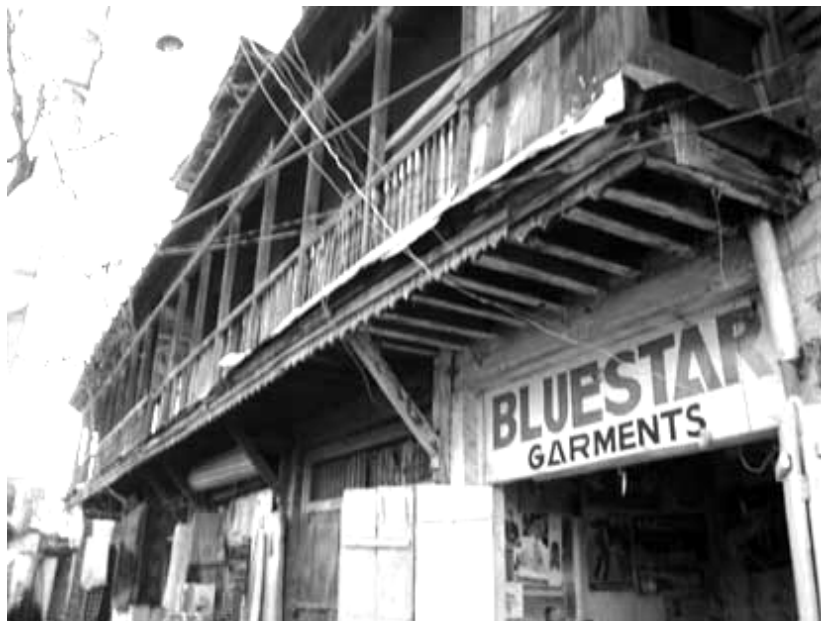
**Figure 5:** Another example of a traditional house with projected balconies built before 1950 that was able to withstand the 2005 earthquake.

Also, several traditional constructions employing structurally stable stone masonry with through stones, well designed arches and retaining walls with corner bastions performed well against the earthquake. Other earthquake safe features found in several traditional constructions in earthquake affected Poonch region in Kashmir include floors/ceilings with joists resting on wooden bands (ties) running all along the walls, well designed trusses, ‘tongue and groove’ joinery and balconies resting on projecting wooden joists. In other constructions, extensive use of wood on the upper floor (in the form of wall paneling, balconies, staircases etc.) significantly reduced the weight, thereby enhancing the earthquake performance of the structures (Figure 5).

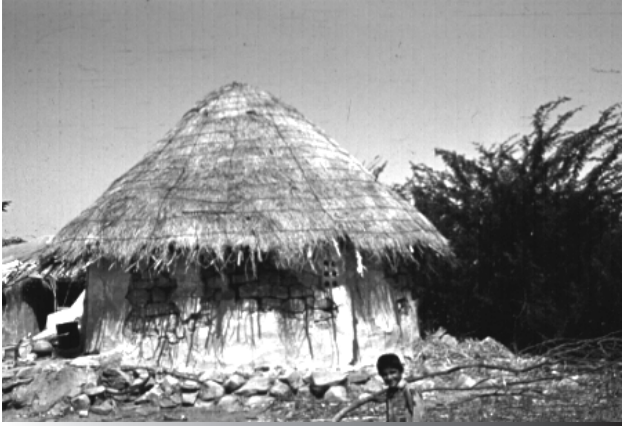
**Figure 6:**

Bhunga in a village near Bhuj in Gujarat. The walls are made of mud applied to an inner wooden trellis, a comparatively ductile and light system. The mud walls and the thatched roof provide reasonable cooling in the hot and arid Rann of Kutch.

Such earthquake safe construction systems have also been found in Gujarat. The typical traditional dwellings of the Kutch region; the *bhungas*, that have withstood the test of time for centuries and have also withstood earthquakes, thanks to their circular form, which is very good in resisting lateral forces of earthquakes. Moreover, their wattle and daub constructions, especially where wood is used as reinforcement for the wall, has proved to be very effective. Its worth mentioning that *bhungas* are not only earthquake safe, they also demonstrate sensitive understanding of locally available resources, climatic conditions and spatial requirements of people (Figure 6). In fact, all these factors play an important role in the evolution of vernacular architecture at any given place.

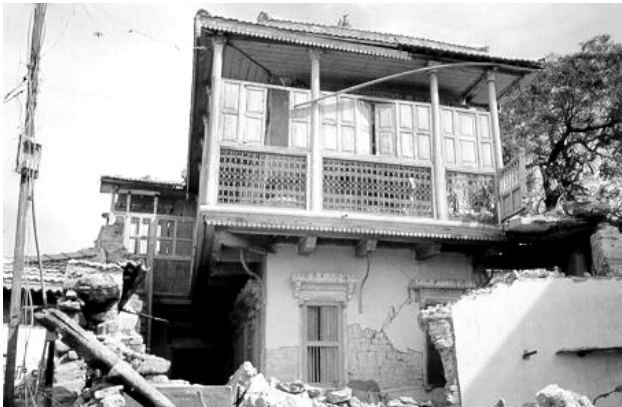
**Figure 7:**

One of the few surviving traditional houses in Anjar which could withstand the earthquake when all newer structures collapsed like pack of cards.

In Gujarat, many structures built prior to 1950s had floor joists extending through the rubble stonewalls to support the balconies. They were more successful in stabilizing the walls than the cases where joists terminate in pockets and, therefore, performed much better against the 2001 earthquake (Langenbach 2001). In fact, in Anjar, this kind of structure was one of the rare ones still found standing amidst endless debris of collapsed houses (Figure 7).

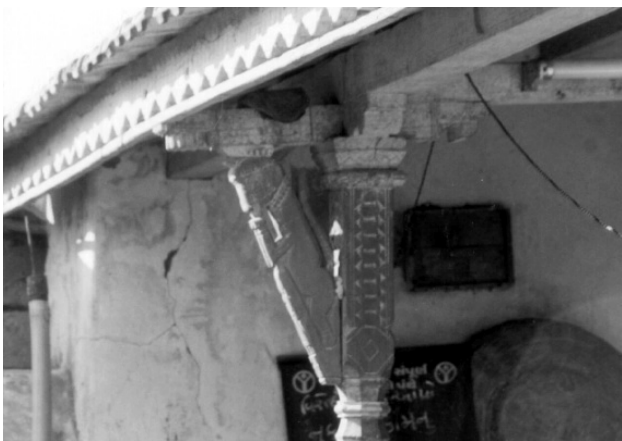
**Figure 8:**

Several earthquake-safe features can also be found in many traditional constructions, such as knee bracing in this case.

Some traditional constructions employing wooden frames with masonry infill also performed well against the lateral forces of the earthquake due to their capacity to dissipate the energy. Several earthquake-safe features are also to be found in many traditional constructions such as tie beams, knee bracing, tongue and groove joinery, etc. (Figure 8)

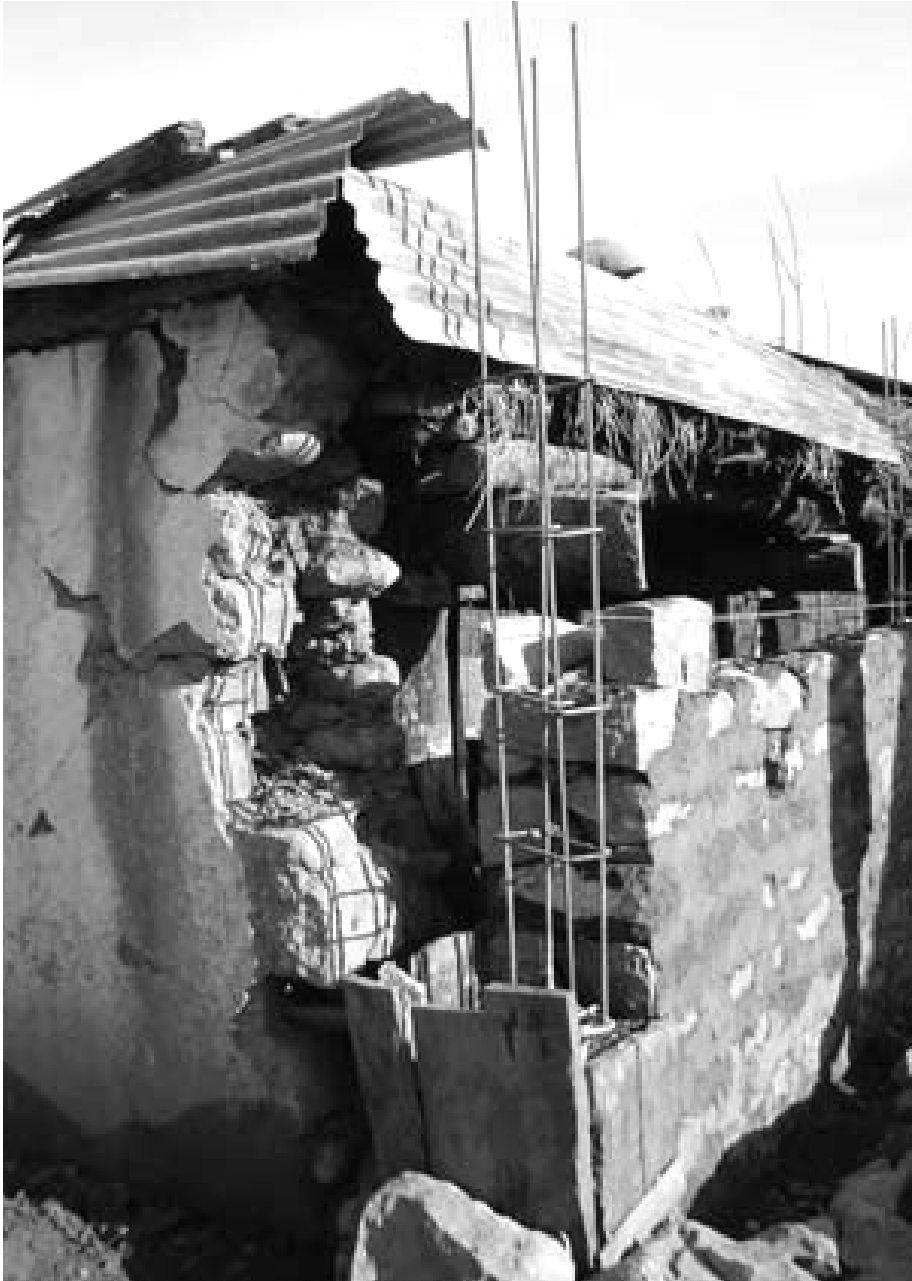
**Figure 9:** Reconstruction of rural houses undertaken by owners following the 2005 earthquake in Kashmir indicate ignorance of techniques for earthquake resistance.

As a result people, started reconstructing in stone without employing earthquake safe practices (Figures 9 &10). One of the reasons for these poor construction practices was the non-availability of trained local engineers and masons. In fact, most of the reconstruction was being undertaken by masons from Bihar, who were not conversant with sustainable local building techniques.

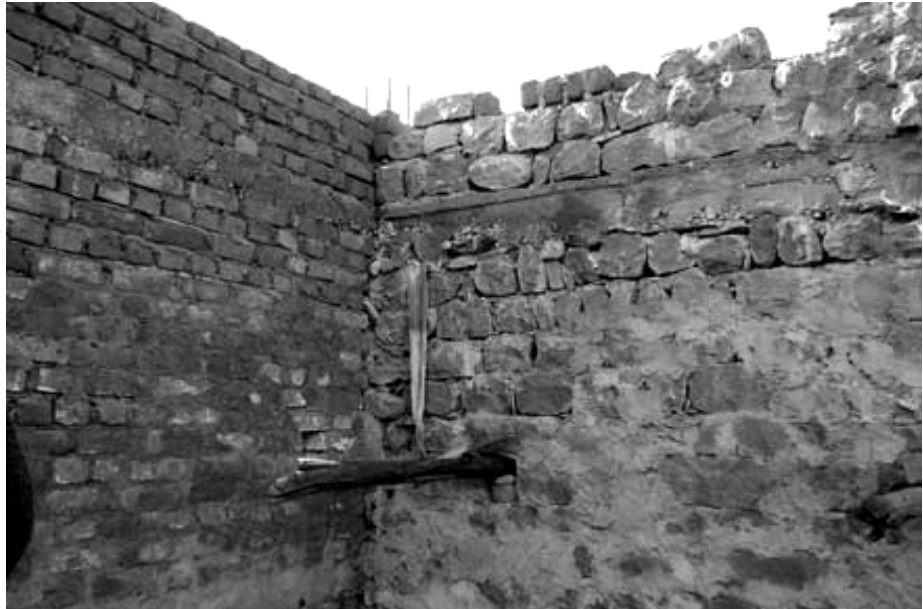
**Figure 10:** Reconstruction of rural houses in Kashmir. The use of composite materials and discontinuous concrete bands indicate a total disregard for basic techniques for earthquake resistance.

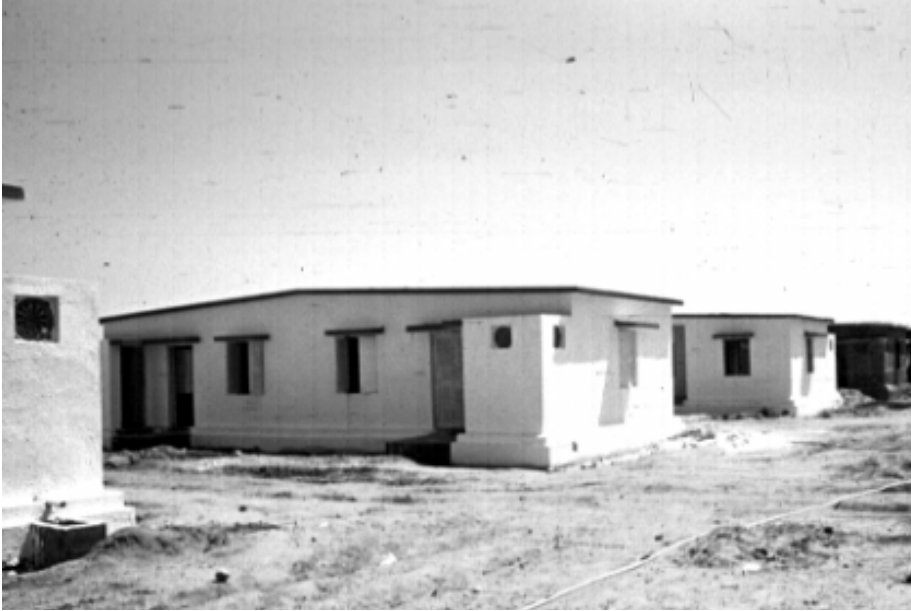
**Figure 11:** Contractor driven reconstructed village following grid iron pattern and box shaped houses show total disregard for the traditional way of life.

In many of these villages, the ‘city-like’ layout and the government criteria of house-size, overlooking traditional spatial planning and design systems, brought out the issue of ‘cultural incompatibility’ (Figure 11).

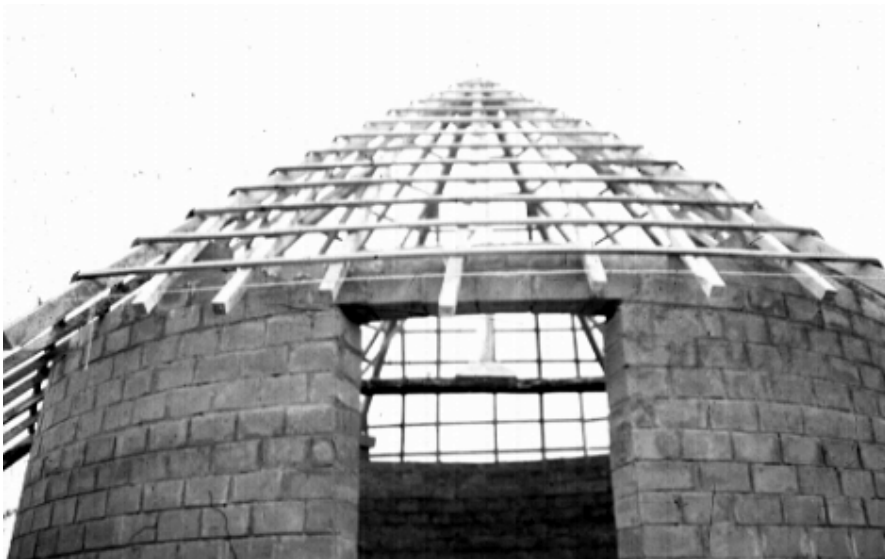
**Figure 12:** Modern Bhungas, constructed by an NGO after the earthquake, retain traditional circular forms but have replaced traditional materials by low-cost compressed soil blocks.

In some villages, traditional circular structures (bhungas) were reconstructed. However, these merely copied the form while changing local materials and technology, bringing forward issues related to their authenticity and sustainability (Figure 12).

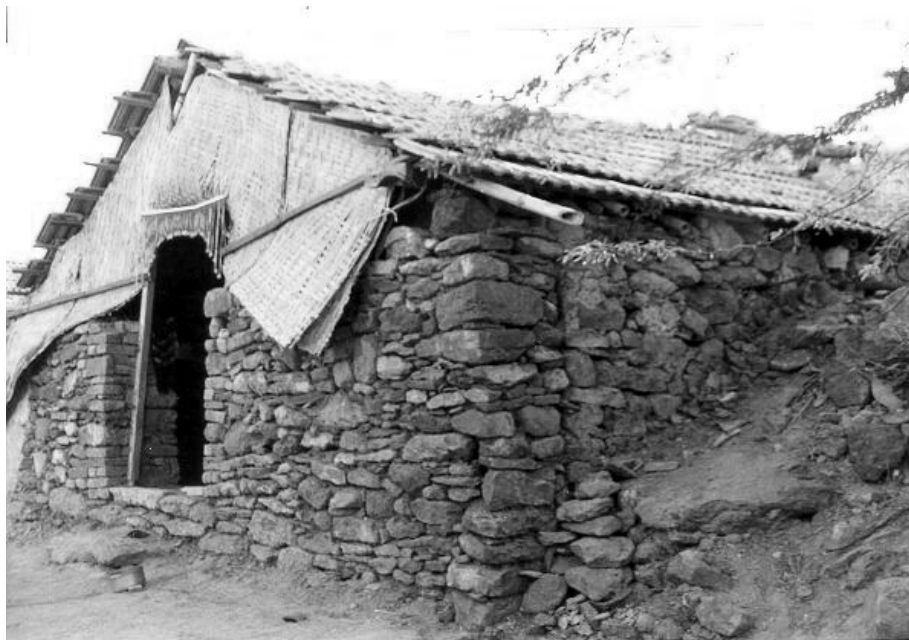
**Figure 13:** Conversion of temporary shelters to permanent houses

However, this did not materialise in time. As a result, by the time the semi-permanent shelters could be erected, people had already initiated permanent constructions and reverted to prevalent unsafe building practices. Over time, many semi-permanent constructions were also made permanent by raising walls in stone, again without any earthquake safe features (Figure 13).
